# Progressive Engineering Inc.

## Step Load Cycle Test

**Client:** I-Stair Systems, Inc.

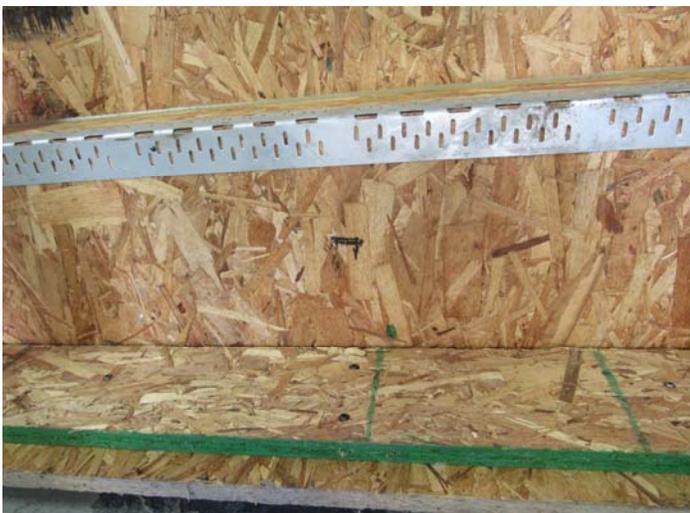
**Conclusion:** The stair-cycle test was a success, with no failures occurring, as well as no visual damage to the I-Stair brackets or gang nail brace. The tread surface in contact with the loading nose was slightly indented by 2x2 loading plate and had a few loose or frayed strands around the perimeter of the loading plate. The actual permanent set and deflection under load may vary from that shown at the completion of the test, due to the shifting in the sample on 6/17/16, however it was included to show that there was no significant material breakdown.

Gangnail brace after 1,000,000+ cycles

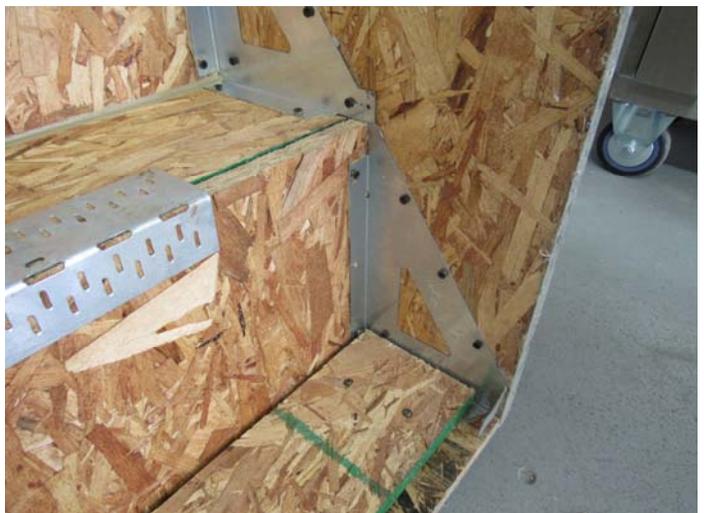
I-Stair Brackets after 1,000,000+ cycles

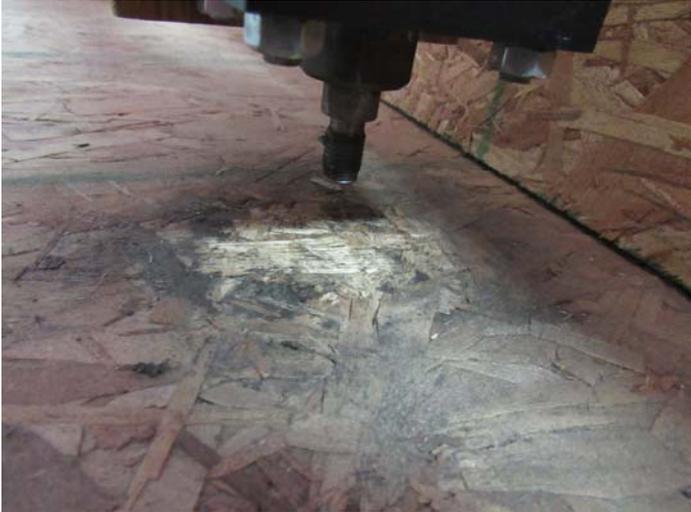
Tread surface after 1,000,000 cycles
